Beaw Field Wind Farm

Outline Habitat Management Plan

Submitted on behalf of
Peel Wind Farms (Yell) Limited

March 2016

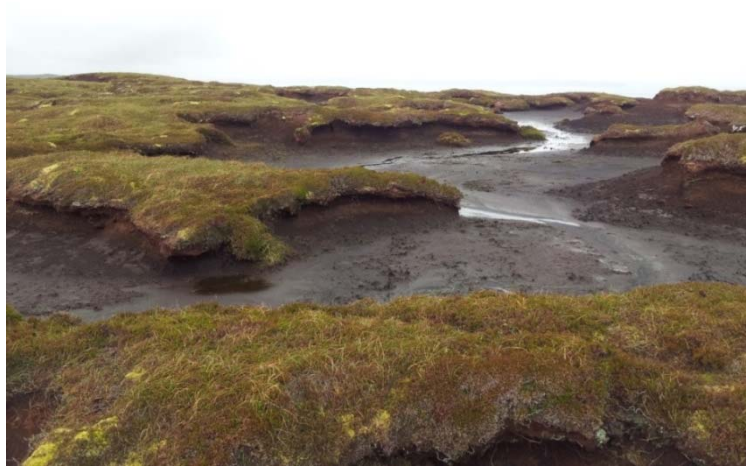
Photo 1: Peat erosion and degraded blanket bog on main ridge between Mossy Hill and Atli's Hill, Yell

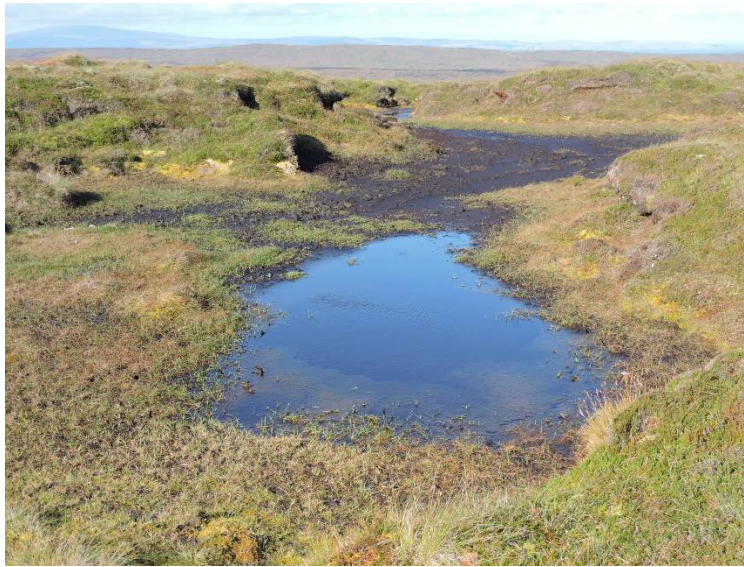
Photo 3. Former red-throated diver Lochan A, eastern end, Yell

Potentially highly suitable former diver lochan for restoration in southern Yell. This former lochan was ca. 50m long by 15m wide. Almost all standing water had drained out of the west end of it, where the peat bank had collapsed due to sheep trampling. There was also a small break in the peat bank along the north side of lochan. If both of these gaps were blocked by plastic dams to restore the lochan then it is estimated that the water levels would reach 70-100cm deep and be level with the surrounding bank edges (important for divers to slide in and out of the water from their nest). The eroded areas of former bare peat have started to be recolonised by sedges and sphagnum, beginning the process of vegetation recovery around the lochan. The following three photos show Lochan A in its current condition (September 2015). Photo 3 shows the eastern end of the lochan, Photo 4 shows the middle and Photo 5 shows the western end where placement of a dam to block outflowing water is recommended.

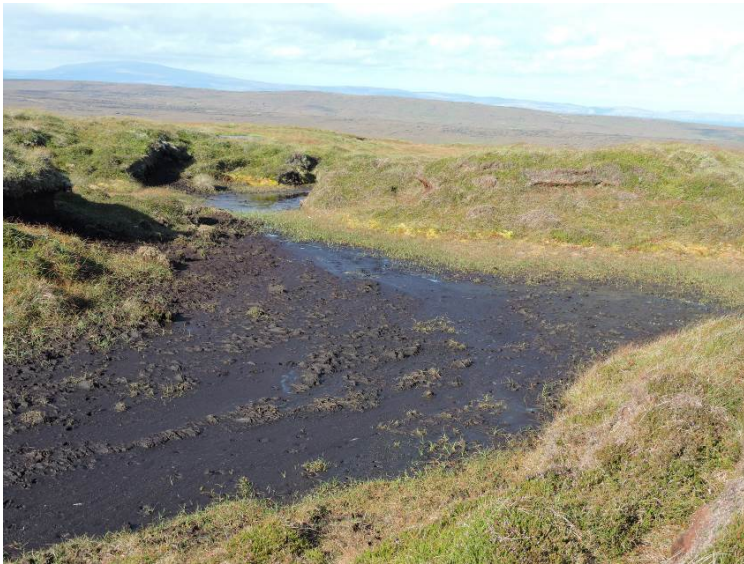
Photo 4. Former red-throated diver Lochan A, middle section, Yell

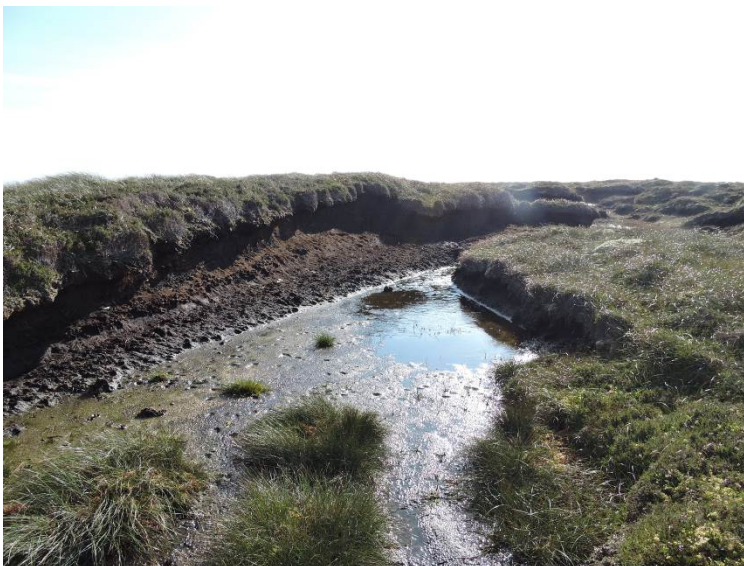
Photo 5. Former red-throated diver Lochan A, western end, Yell

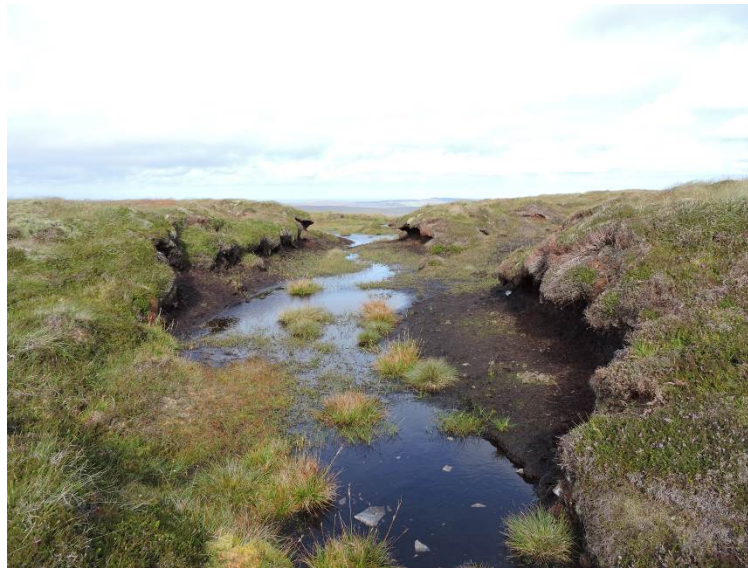
Photo 6. Former red-throated diver Lochan B, eastern end, Yell

Potentially highly suitable former diver lochan for restoration in southern Yell. This former lochan was ca. 45m long by 10m wide. This location is close to Lochan A, being 60m to the south of it, along the same ridge. Almost all water had drained out of its west end, where the peat bank had collapsed due to impacts from sheep. There was also a small eroded break in the peat bank along the southwest side of lochan. If both of these gaps were blocked by plastic dams to restore the lochan then it is estimated that the water levels would reach ca. 1m deep and be level with the surrounding banks. The former areas of bare peat around the lochan have been recolonised by sedges and *sphagnum*, beginning the process of vegetation recovery around the lochan. The following two photos show Lochan B in its current condition (September 2015); Photo 6 shows the eastern end of the former lochan and Photo 7 shows the western end.

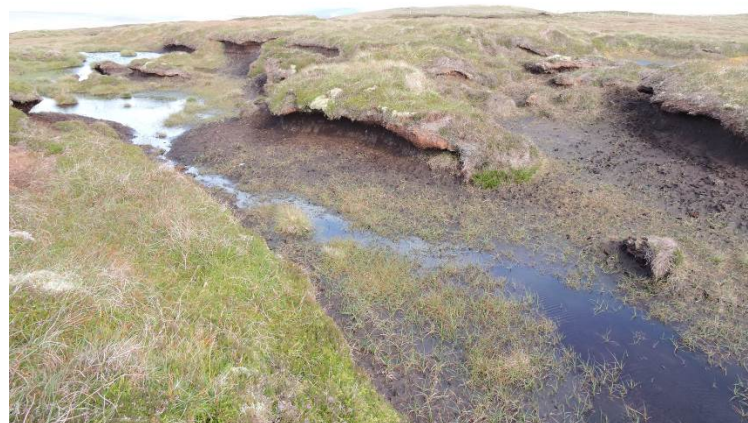
Photo 7. Former red-throated diver Lochan B, western end, Yell

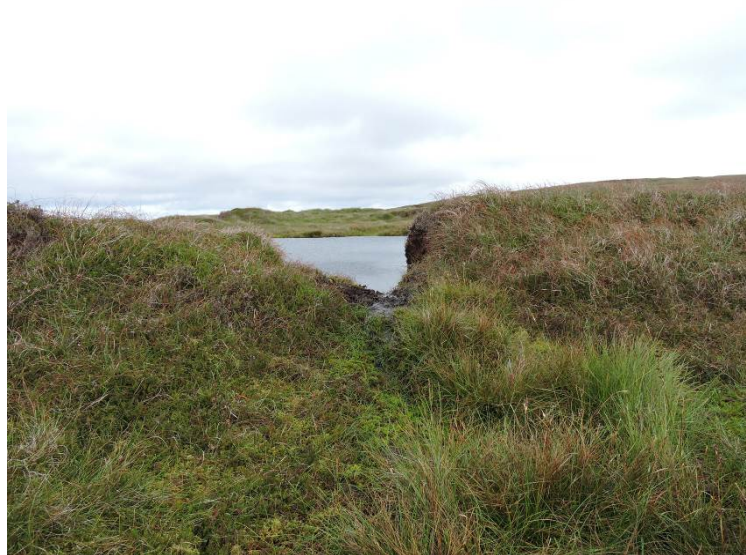
Photo 8. Former red-throated diver Lochan C, eastern loch eroded gap, Yell

contain water, but have shallow, reduced depth due to a small eroded gap on the bank where it has collapsed due to trampling by sheep. The two lochans are separated by a small 1-2m² area of collapsed bank. By removing the collapsed bank and plugging the small gap at the east end of one lochan the two current lochans should reform into one larger one. The areas of former degraded peat have recolonised well by sedges and *sphagnum* and the process of vegetation recovery around the lochan is well underway. Unfortunately, this will not result in the plugging of the eastern lochan gap or the joining of the two lochans. The following three photos show Lochan C in its current condition (September 2015); Photos 8 and 9 show the eastern lochan and its eroded gap, which has been identified for blocking with a plastic dam and Photo 10 shows the collapsed bank blocking and separating the two shallow lochans from meeting.

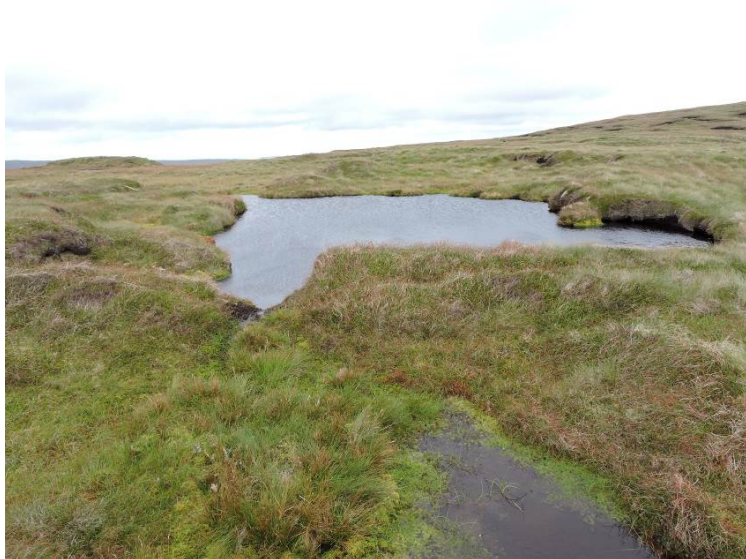
Photo 9. Former red-throated diver Lochan C, eastern loch, Yell

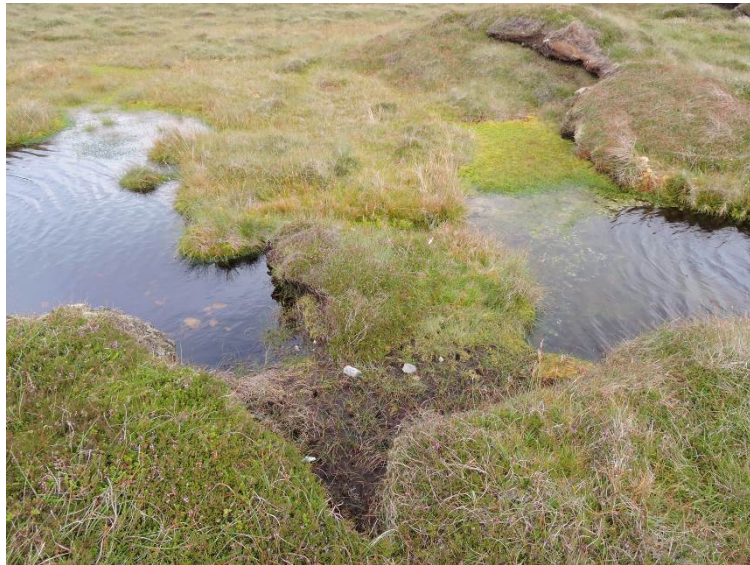
Photo 10. Former red-throated diver Lochan C, collapsed middle section separating two shallow lochans, Yell

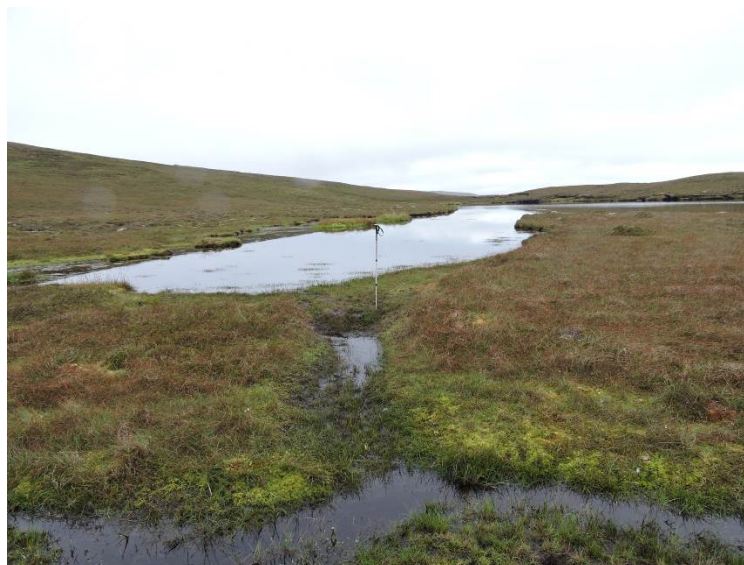
Photo 11. Lochan D, southern end, Yell

This waterbody is a relatively large lochan. At the southern edge of the lochan, peat erosion has occurred (and is still occurring), mainly through trampling by sheep and the lochan water is now held back from draining by a narrow patch of vegetated peat (marked by walking pole in Photo 11). Although water levels are currently suitable for nesting divers, it does appear that this narrow plug of vegetated peat has been degraded and if it fails, then the lochan will rapidly drain away and become empty, resulting in the loss of a suitable diver nesting lochan. It is recommended that a plastic dam is placed at this location to strengthen the natural peat plug and retain water in the lochan.

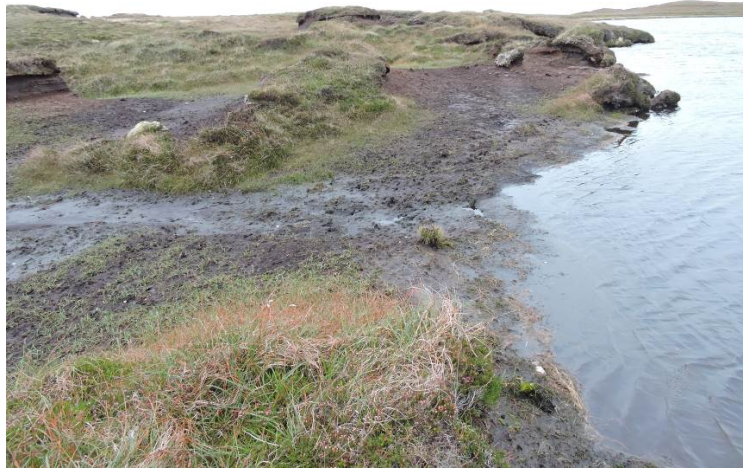
Photo 12. Lochan E, western edge collapsed peat bank, Yell

This waterbody is a relatively large loch that has previously held breeding red-throated divers. The peatland habitats in the southwest of this waterbody have historically been severely degraded by the trampling and passage of many sheep. In particular, a peat bank along the western edge has eroded away and lochan water is now draining out of a break in the peat bank (Photo 12), lowering the water level and making the site unsuitable for breeding divers. Recent reductions in sheep grazing in this area have resulted in the bare areas of peat being recolonised by sedges and *sphagnum* mosses.

Blocking the peat outflow with a plastic dam will result in the water levels returning towards previous natural levels, creating suitable conditions for divers to regularly breed here again.

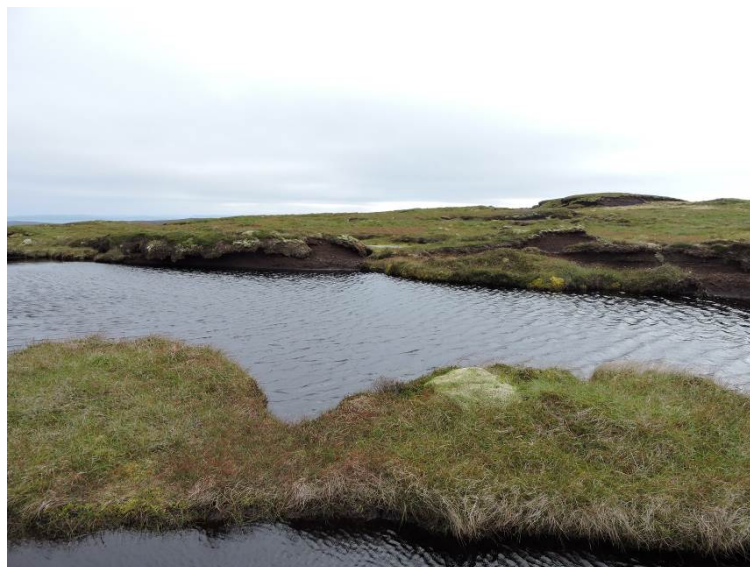
Photo 13. Lochan F bare, peat lined banks, Yell

This lochan in southern Yell and is within an area of reduced grazing and peatland habitat improvement. Nevertheless, substantial damage and erosion has occurred, altering the water levels in this former red-throated diver breeding lochan. Photo 1 shows the bare peat lined banks caused by low water levels and Photo 14 shows an eroded outflow at the western edge of the lochan and the island they presumably formerly nested on. Simply blocking the outflow would result in water levels rising and restoring the site into a condition likely to be more suitable for breeding red-throated divers.

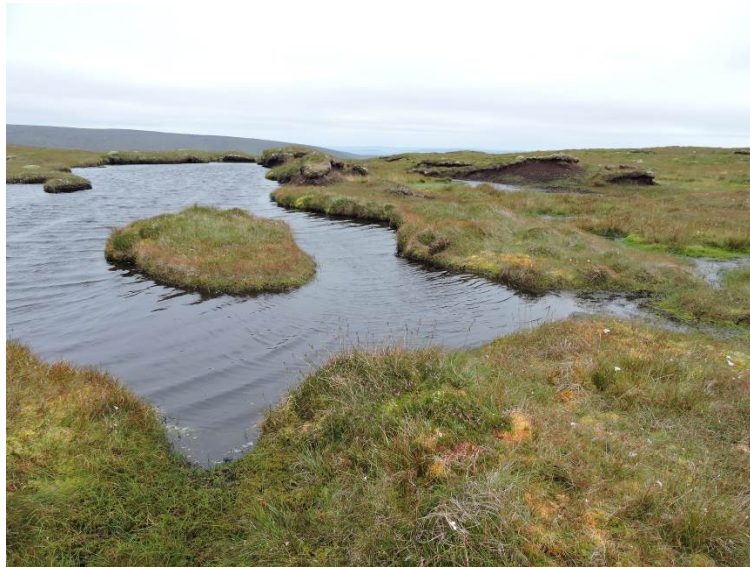
Photo 14. Lochan F eroded outflow, western end, Yell

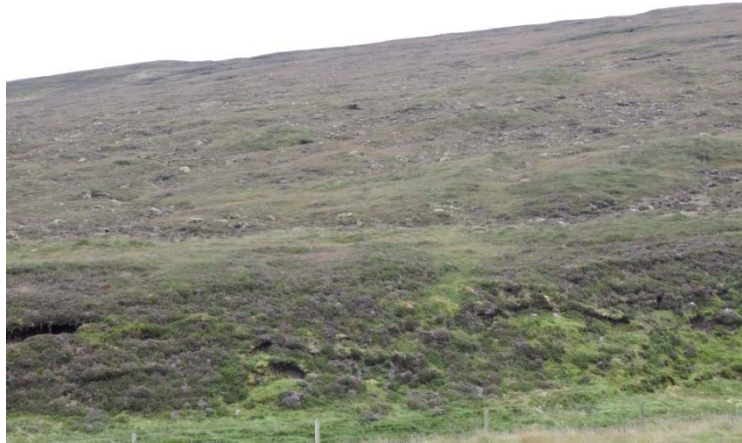
Photo 18: Heavily grazed former merlin breeding habitat West Hill, Yell

Exclosure 1 - the east facing slope of West Hill which overlooks Aris Dale. The east slope of West Hill is a historical merlin nest site, but it appears not to have been used for several years (e.g. not in 2011-2015). There is plenty of heavily grazed heather still present and a reduction in grazing pressure should allow the heather to grow much longer, creating suitable preferred merlin nesting habitat.

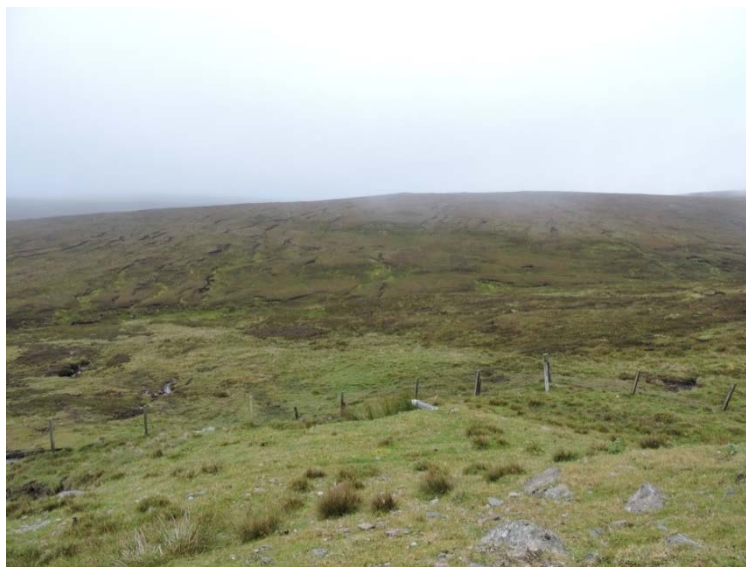
Photo 19: Heavily grazed former merlin breeding habitat Stouraclev, Yell

Exclosure 2 - the east facing slope of Stouraclev (e.g. HU 496 820), which overlooks Burn of Hamnavoe. This area is currently heavily grazed by sheep. Fencing off a steep area from sheep should allow heather to be restored and to become long and rank within a relatively short space of time.

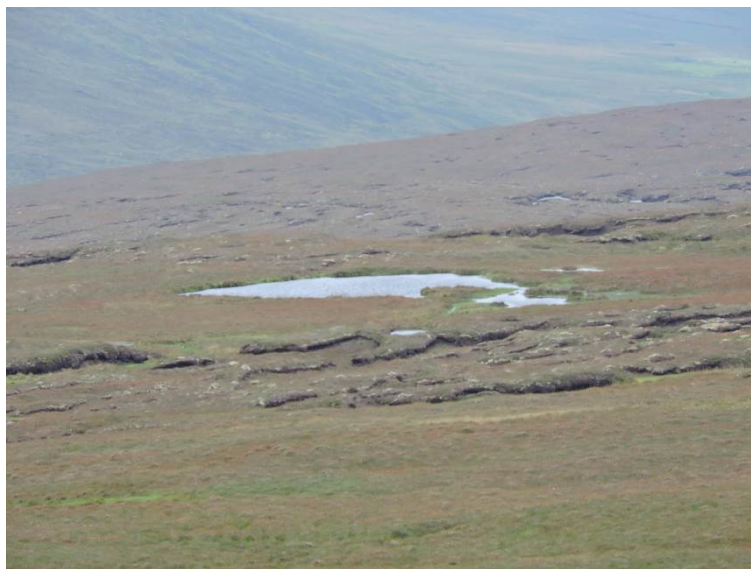
Photo 15. Recovering blanket bog habitat, Hill of the Waters, West Yell

The large reduction in grazing pressure on adjacent land owned/managed by John Ballantyne (West Yell) demonstrates how rapidly peatland vegetation can recover on exposed hills in southern Yell with a substantial reduction of grazing pressure. Formerly bare, eroded and hagged peat has become revegetated, stopping erosion damaging important features such as red-throated diver lochans (Photo 15). The signs of vegetation and habitat recovery are everywhere to be seen in the West Yell Common Grazings, with little or no bare peat now that grazing pressure is low (in contrast to large part of the Study Area).

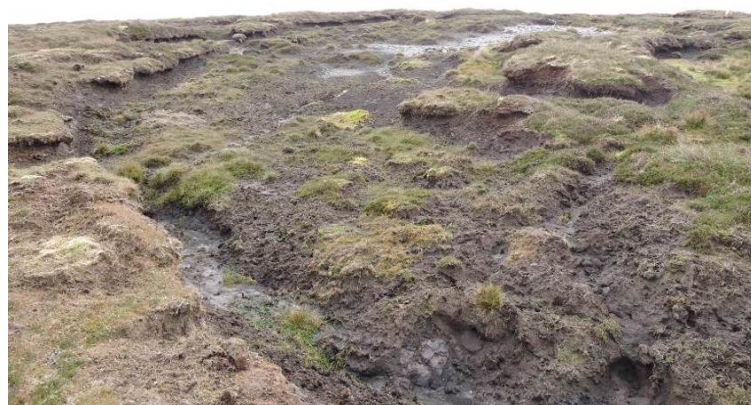
Photo 16. Degraded blanket bog habitat, Mossy Hill, Yell

Peatland restoration will take place primarily through reductions in grazing pressure over the entire Application Boundary area, ca. 1,158ha. The maximum number of sheep allowed in the area at present is 1,800 units (sheep), the actual current figure grazing is ca. 1,200 sheep and, through the HMP, sheep numbers will be reduced down to a maximum of 600. The evidence from West Yell suggests that a large scale reduction in grazing pressure should result in bare peat surfaces (Photos 16 and 17) and hags naturally revegetating with little or no other interventionist management.

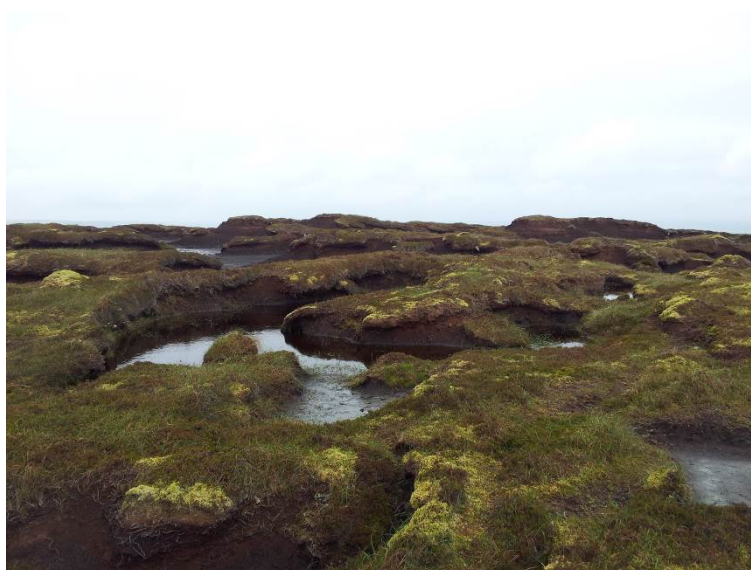
Photo 17: Degraded blanket bog on western side of main ridge between Mossy Hill and Atli's Hill, Canis Dale, Yell

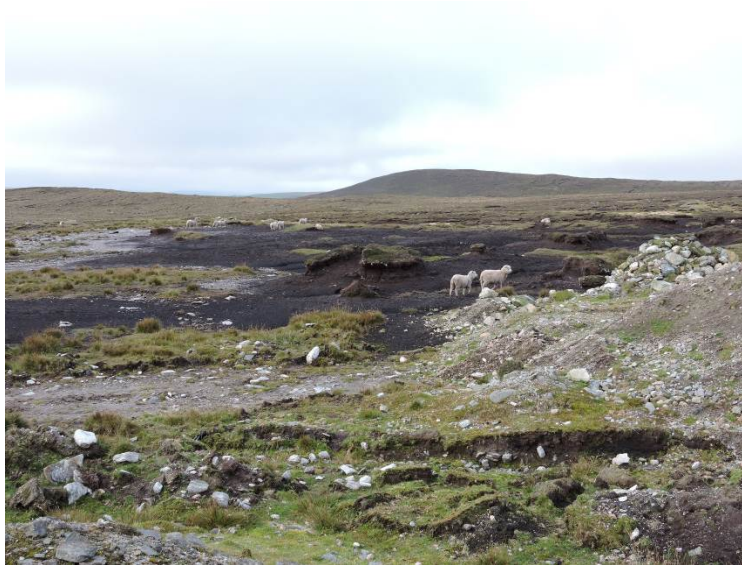
Photo 18: Degraded blanket bog habitat, eroded down to the mineral soil at Moss Houll, Yell

It is recognised that not all areas of blanket bog habitat will recover quickly without intervention. The area around Moss Houll has been severely degraded by both over-grazing and peat cutting (Photo 18). Nevertheless, the majority of peatland habitat the Application Boundary area is likely to recover with a substantial reduction in grazing pressure. An important element of the HMP will be to monitor vegetation recovery and areas of bare peat to ensure the reduction of grazing pressure delivers the anticipated blanket bog recovery. If monitoring demonstrates this has not occurred, further management such as additional reductions in grazing pressure, hagg reprofiling, mulching, seeding and potentially fencing may be required. The planned habitat monitoring will determine what, where and if additional management intervention is required.

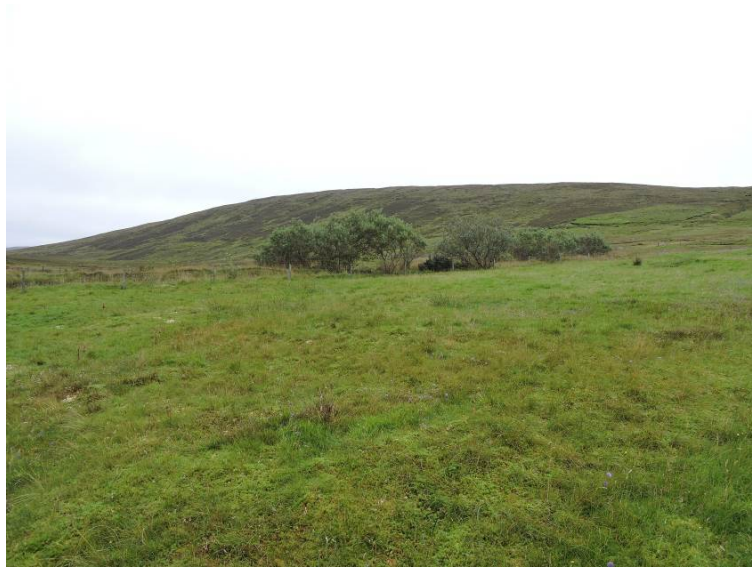
Photo 20: Small, remnant patch of planted broadleaved trees, Arisdale, Yell

There is a very small remnant patch of planted broadleaved trees along the Burn of Arisdale at Arisdale croft (HU 48274 82212) (Photos 21 and 22).

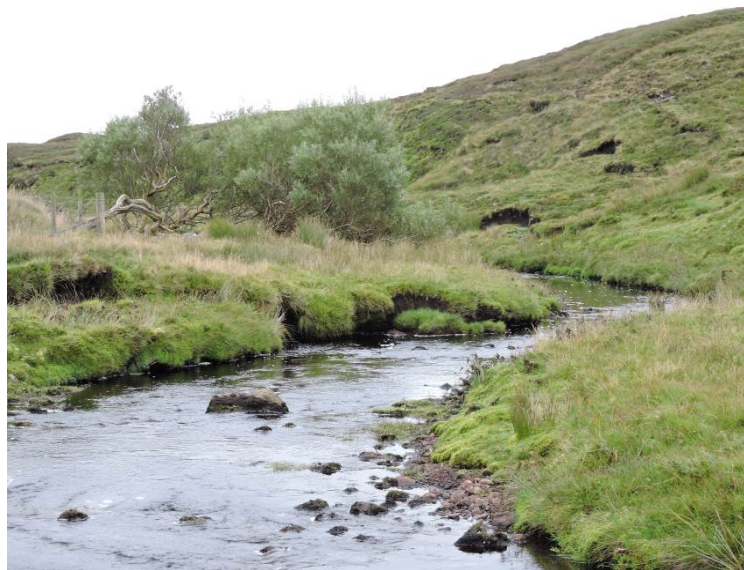
Photo 21: Small, remnant patch of planted broadleaved trees along Burn of Arisdale, Yell
