**Beaw Field Wind Farm, Yell, Shetland Isles:
Fish Habitat and Electric Fish Survey Report**

Commissioned Report
November 2015

Waterside Ecology

Beaw Field Wind Farm, Yell, Shetland Isles: Assessment of fish habitats and populations

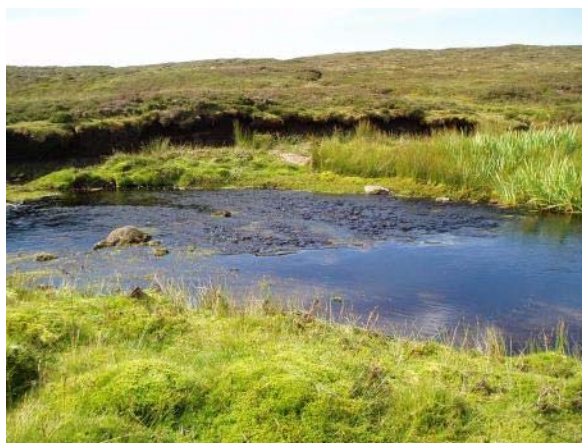
Figure 3 Section AR4

In most sections the stream banks are stable, although some erosion and undercutting was apparent on the outside of bends in section 4 (Figure 3). This erosion is not viewed as detrimental as it provides a source of some spawning calibre material to the watercourse.

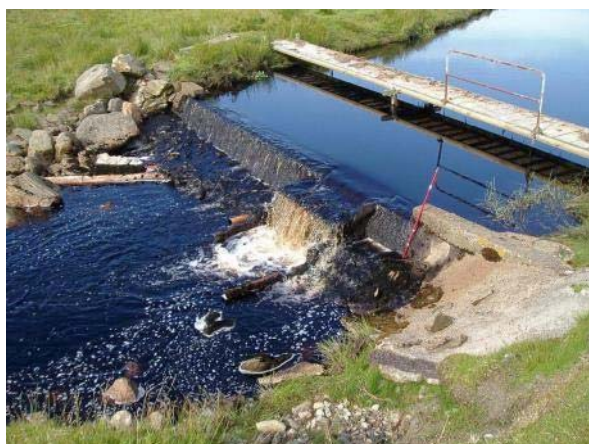
Figure 4 Weir at HU 4854 8121

The bridge apron at HU 4854 8121 was inspected. Water flow over the apron is concentrated and permits sufficient depth for fish passage. It does not form a significant obstacle to migration of salmonids or eels. The weir at HU 4858 8130 forms a more significant obstacle. The weir (Figures 4 and 5) spans the full stream width. The weir face is approximately 0.7 m high. Its ascent is complicated by the presence of shallow sill below the weir face, which does not provide sufficient depth for fish to jump. Flow over the weir is concentrated through a notch below which there is a structure that may have been a fish pass. However, the walls of this structure appear to have collapsed and it no longer provides sufficient depth for fish jumping at the weir face. The weir may be passable for salmonids at some water levels. Nevertheless, this is uncertain and it seems to represent a significant barrier that would impede upstream passage at some water levels. The weir face has a dense growth of bryophyte and this provides suitable climbing substrate for glass eels (juvenile upstream migrants).

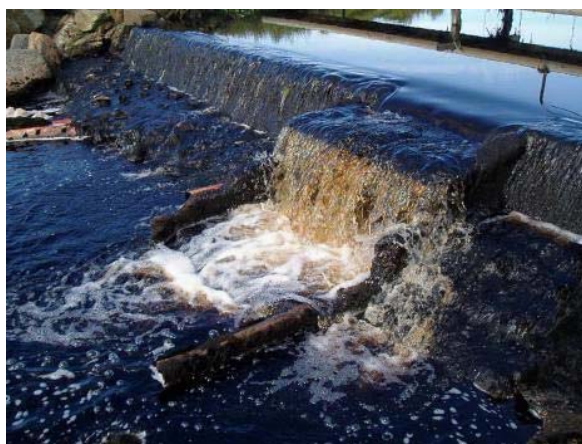
Figure 5 Weir at HU 4854 8121

The lower reaches of Burn of Arisdale are typically between 5 m and 7 m in wet width. The gradient is low to moderate and flow types are varied, with runs and riffles as well as more gently flowing glides and pools. Sections AR1 to AR3 provide long reaches of stable boulder and cobble habitat that appear well suited to the production of juvenile salmonids. Depth is typically between 10 and 40 cm and cover on the streambed is plentiful, both from boulders and from macrophytes. In most places the wetted channel abuts one or more bank and some additional overhead fish cover is available from undercut turf. Some deep pool habitat is available that would provide resting areas for adult salmon or trout. This includes a large pool impounded behind the weir in section AR2.

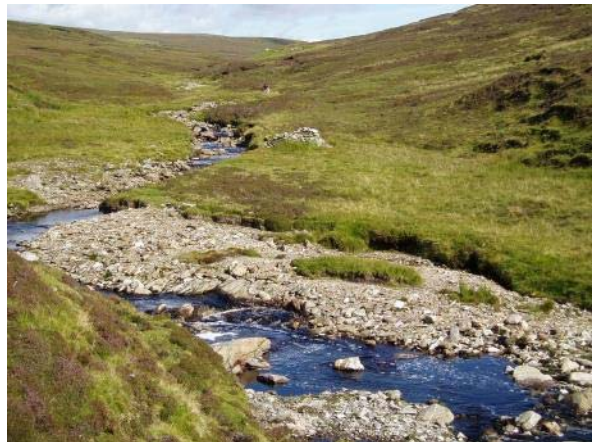
Figure 8 Section HA6

The next four survey sections to HU 417 819 have a moderate to steep gradient. There is some stable boulder habitat but smaller substrates appear mobile and spawning habitat is lacking. Large depositional bars are present on bends through sections HA4 to HA6 (Figure 8). Depth is typically

between 15 and 40 cm and flow types are dominated by runs and riffles with occasional shallow pools. The latter provide some good quality habitat for trout parr.

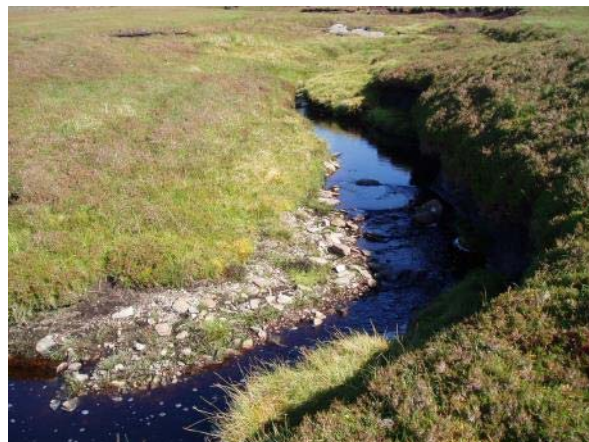
Figure 11 Section HA16

The unnamed tributary stream at HU 4990 8256 is typically between 0.5 m and 1 m wet width. It flows through peat hags and there is some braiding of the channel. In general, trout habitat quality is poor or moderate as much the stream is shallow and cover on the streambed is lacking. Nonetheless, trout

were seen in all three survey sections (HA16 to HA18). Spawning habitat is scarce in this stream and only one patch of 0.5 m² was recorded.

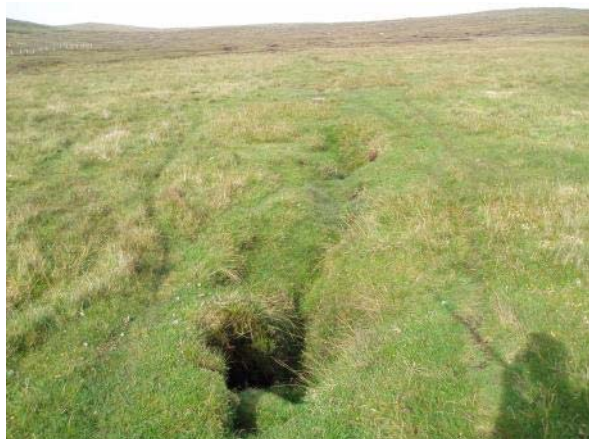
Figure 14 Section EV1 in Loch of Hamnavoe

Burn of Evrawater was surveyed non-quantitatively from the edge of Hamnavoe village (HU 5003 8076) upstream to HU 5048 8149. The lower reaches are in Loch of Hamnavoe, an area of marshy ground where the stream is dissipated among several braided channels, which frequently disappear beneath the turf. The streambed in this area is mainly mineral hardpan or peat. Further upstream the burn comprises a simple incised channel with runs and little pools. Depth is typically less than 10 cm and the streambed is peat or mineral hardpan. The burn was very turbid and much eroded peat is present in the pools. Habitat quality for is very poor and there is no spawning substrate.

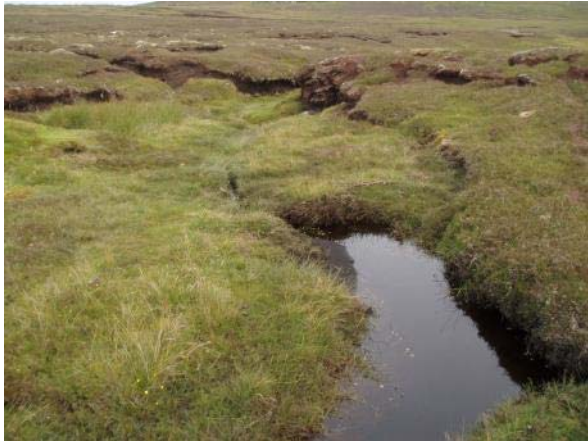
Figure 16 West inflow (section KeW)

The western stream conveys no hard substrates. However a little loose pebble and gravel is present in the eastern stream and there is 5 m² of spawning calibre substrate in a gravel fan where the stream enters Loch of Kettlester. This might permit trout to spawn.

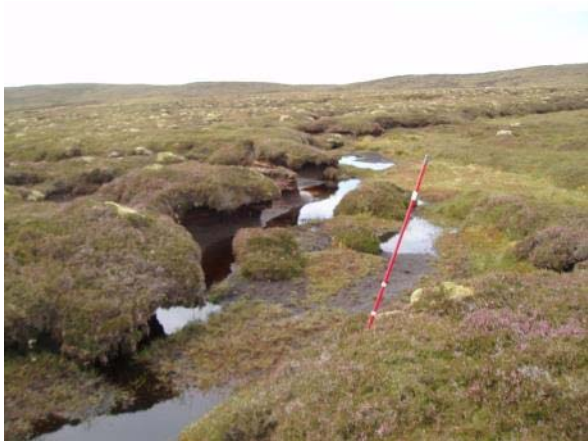
Figure 17 East inflow (section KeE)

The more easterly stream enters Loch of Kettlester at HU 5141 5129 via a 15 m long peat pipe, where the flow is below ground. The streambed in the lower 50 m of the watercourse is mineral hardpan with a little scattered pebble and gravel. Further upstream the burn is a poorly defined channel through peat hags with near-stagnant pools linked by tiny runs. It is totally unsuited to salmonid fish.

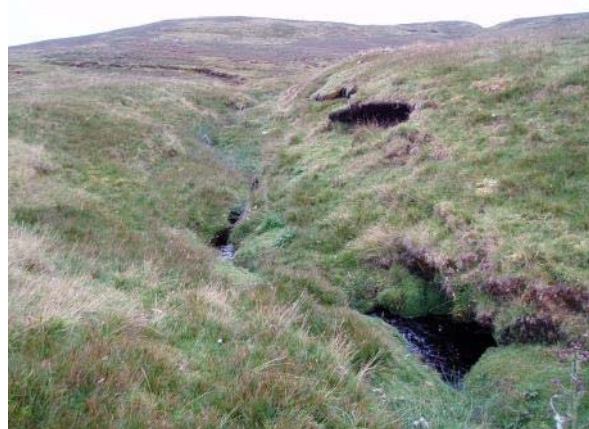
Figure 19 Section HO1

Burn of Horsewater is a small, steep burn with a mean gradient of approximately 6%. Wet width is typically between 0.5 m and 0.8 m and the stream tumbles down the hillside in series of runs and small torrents. Parts of the stream have step-pool morphology but the lower reaches near Loch of Mid Yell have gentler gradient with some glides and runs. Substrates are mainly immobile with little bed transport. Substrate composition is predominantly boulder and cobble set into peat or mineral hardpan. No spawning habitat was recorded (Table 4) and habitat quality was judged to be poor, although some of the little pools appear capable of supporting small numbers of trout. In places the burn disappears underground for up to 15 m and it is uncertain if salmonid fish have access all the way up to Horse Water.

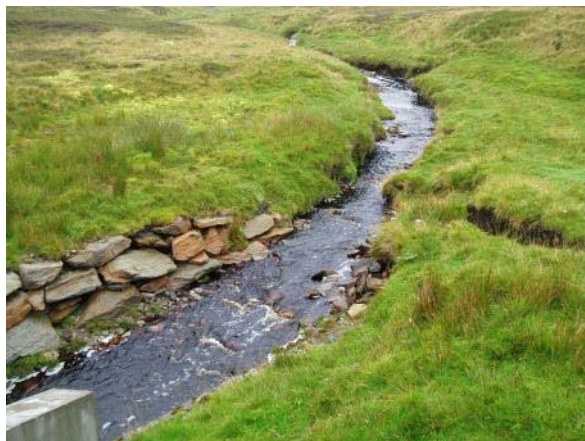
Figure 21 Section GR1

An estimated 602 m² of productive juvenile salmonid habitats were recorded in the survey reaches of Green Burn representing an estimated 39% of the wetted area (Table 4). A further 35% was recorded as glide or pool, both of which would be expected to support trout since overhead cover was plentiful.

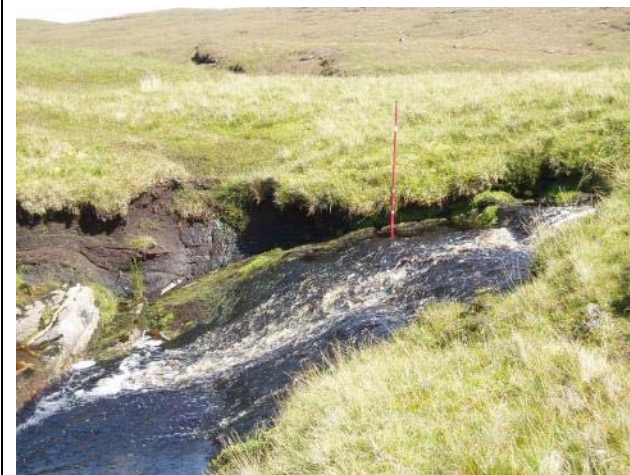
A sloping rock ramp at HU 5009 8273 in section HA11 presents a potential obstacle to upstream migrating salmonids. It is approximately 1.4 m high and 1.8 m long and water flow over the face is very shallow. At the time of survey it was clearly impassable. However, it is possible that the plunge pool at its base may fill on a higher flow, which combined with increased depth over the face of the ramp, might allow fish to ascend by burst swimming.

Section HA11. Rock ramp at HU 5009 8273

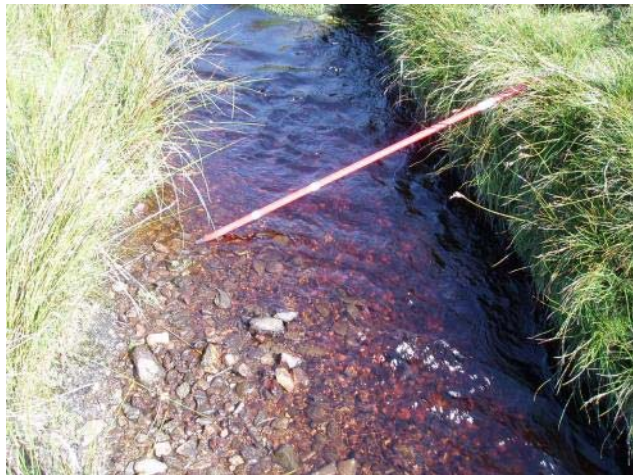
Section HA12. Spawning substrates at HU 5012 8275

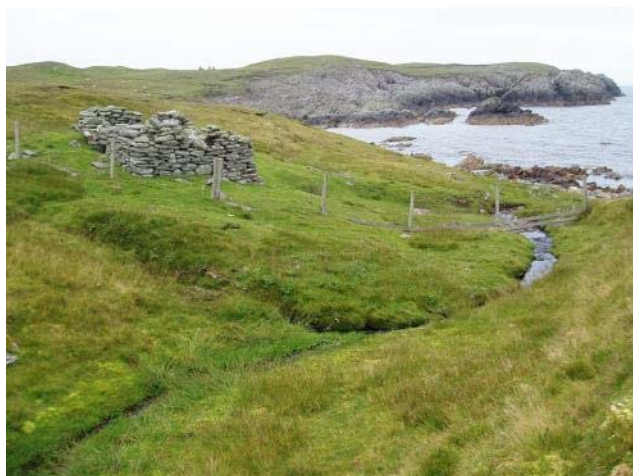
Mill Burn near NTL (ruined click mill behind fence)

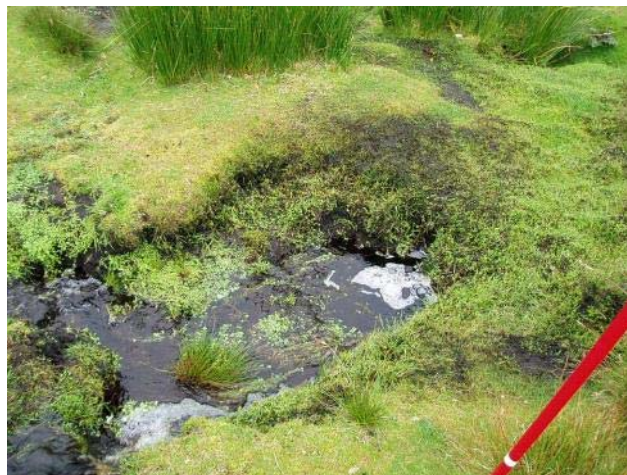
Section HO4. HU 5228 8131 (downstream end of peat pipe)

Litla Water outflow	HO3	HU 5239 8156	HU 5228 8170	Tiny channel incised in peat alternating with poorly defined wet flush habitat. Totally unsuited to salmonid fish.	Wet flush and incised peat.
Swarta Shun outflow	HO4	HU 5238 8148	HU 5220 8126	All visible substrate is peat. Much of the section is below ground. The rest is a simple incised peat channel with some small pools close to Horse Water.	Incised peat. Banks close over stream in many places.
Green Burn	GR1	HU 5201 8318	HU 5196 8300	Lower part of survey section is 1.8 to 2 m wide with substrate of slightly unstable angular cobble, boulder and pebble. Gradient is moderate to steep with many sections of run and riffle. Depth 10 to 30 cm. Gradient eases approximately 80 m upstream of the Gossabrough road bridge and the stream is 30 to 80 cm with glide and pool flow types linked by short runs. Substrate in these reaches is partly embedded, stable boulder and cobble with some granule.	Low stable grassy banks in lower reaches giving way to stepper incised peat faces further upstream. Wet width mainly equals bed and undercuts provide plenty overhead cover.

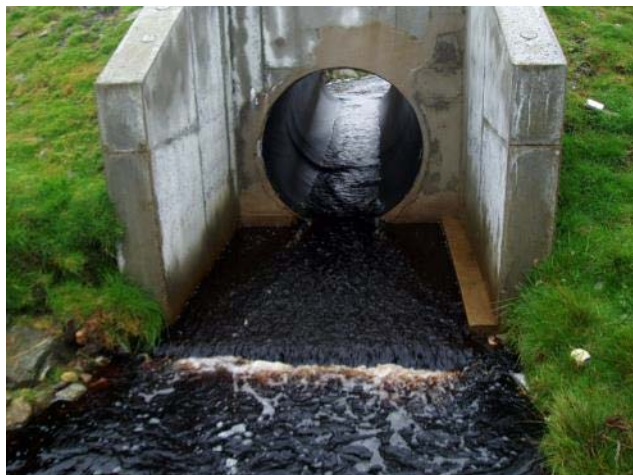
Section GR1. Culvert at HU 5201 8318

The stream flows through culverts beneath the Gossabrough road (HU 5201 8318) and the B9081 road (HU 5180 8264). The Gossabrough road culvert has a shallow, flat downstream sill and is likely to hinder upstream movement of salmonid fish on low and moderate flows due to lack of depth. It is likely to be passable on a higher flow, although in full spate conditions stream velocity through the sloped culvert may be a concern.

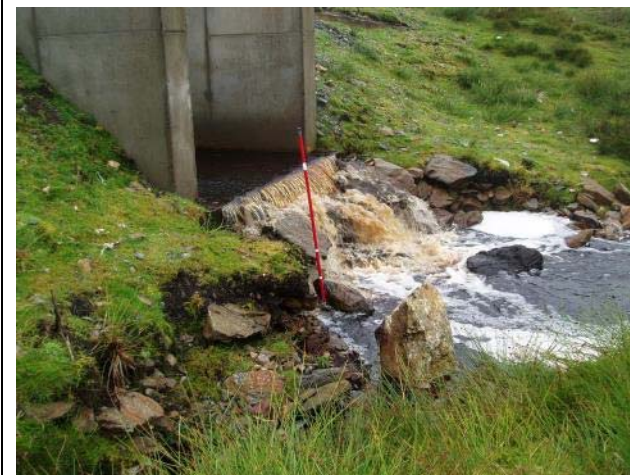
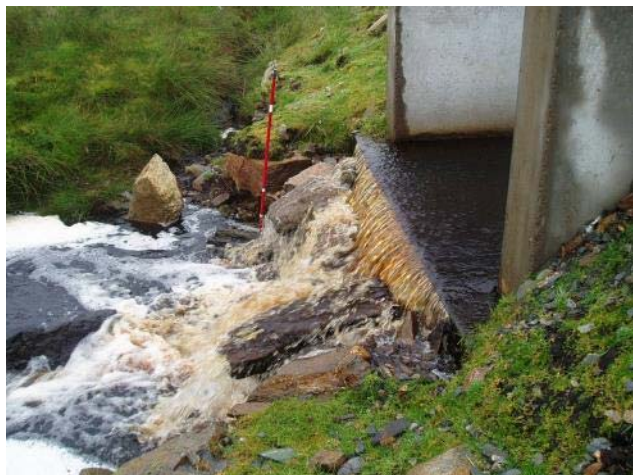
Section GR3. Culvert at 5180 8264

The downstream end of the culvert at the B9081 is perched at approximately 0.75 m above the stream surface. An apron of large boulders extends downstream of the culvert, resulting in very poor conditions for fish to attempt to jump into the culvert. It is uncertain whether this obstacle is passable to salmonids. However, given the very poor quality and limited extent of stream habitat upstream of the road an obstacle at this location can have little impact on fish abundance in the stream. Photographs of both culverts are provided in Annex 7.7.

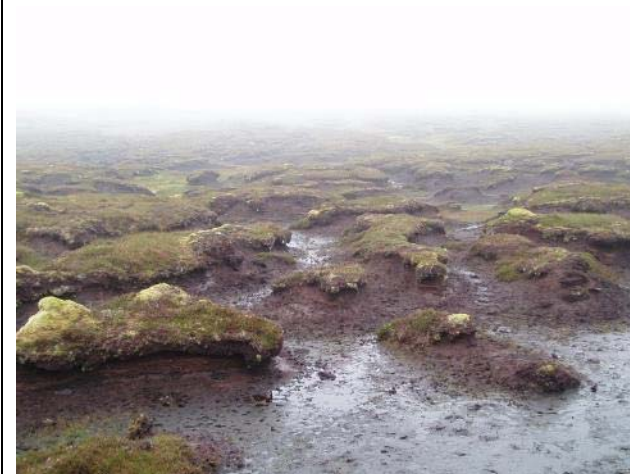
Section GR4. Riparian habitat at HU 5165 8249

Watercourse	Section Code	NGR		Instream habitat description	Banks and riparian habitat
		Downstream	Upstream		
				section of boulder habitat immediately downstream of the B9081 road.	
Green Burn	GR4	HU 5180 8264	HU 5162 8241	Channel is incised through peat. Broad pools are linked by narrow runs. Substrate is almost entirely peat with a few areas where coarse sand and gravel form a thin layer on top. Depth typically 30 cm to 1 m. Poor quality habitat for trout or eels.	Incised peat with overhead cover from undercuts. Upper reaches flow through eroded peat hags.

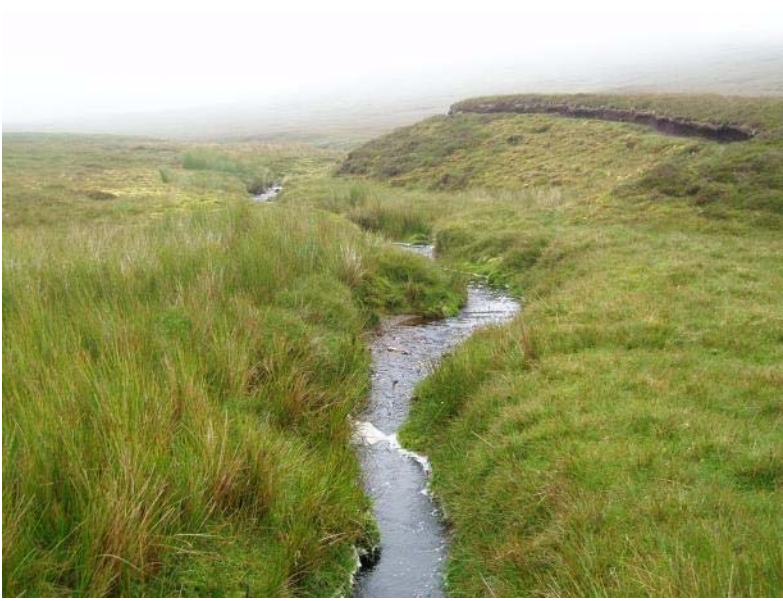
<p>H3 site – typical habitat at survey site</p>

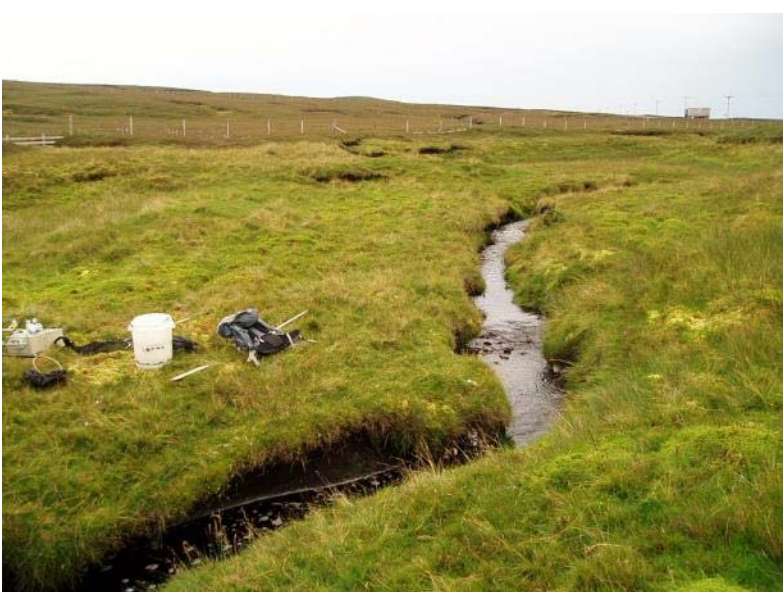
<p>G2 typical habitat at survey site</p>
